Arboricultural Assessment Report

Bluebell

Naas

Project No.	Project name	Date	Revision
TBLU001	Bluebell	31/10/18	A

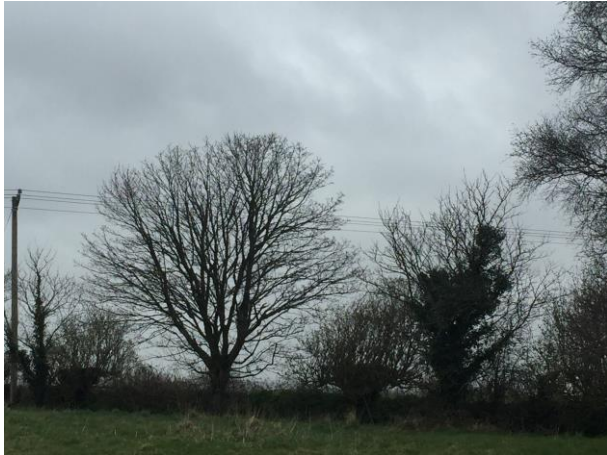
On the southern boundary, there are young sycamore (*Acer pseudoplatanus*) within an agricultural hedgerow (image 2) with two small shelterbelts of Leyland cypress (*xCuprocyparis leylandii*) and a Monterey cypress cultivar (images 3&4). In addition, there are birch (*Betula pendula*) and Swedish whitebeam planted to the east of the Monterey cypress (image 5). In terms of the re-development of the site, the birch and sycamore probably provide greatest potential for retention in terms of their landscape value.

Image 2. Young sycamore on southern boundary

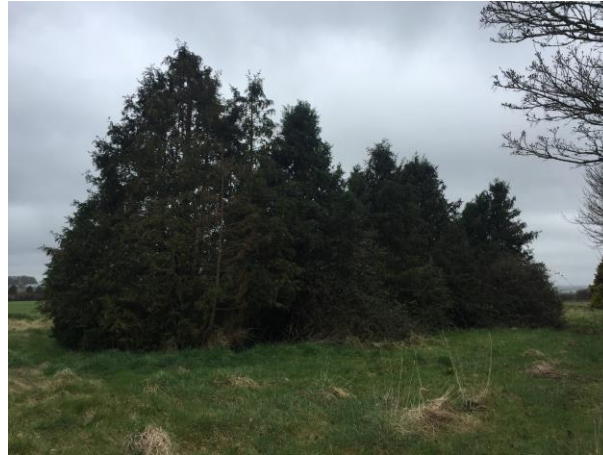
Image 3. Leyland cypress on southern boundary

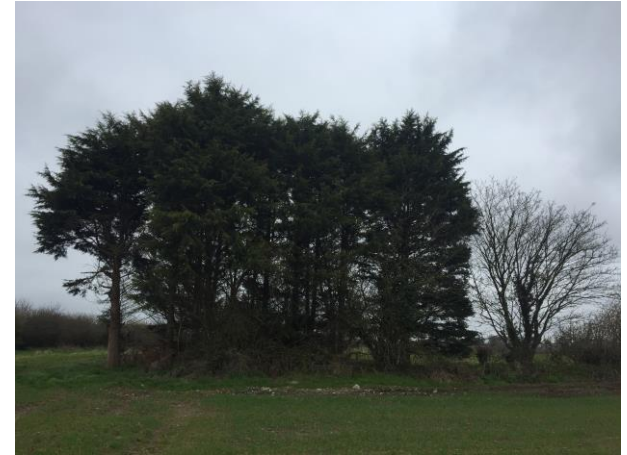
Image 4. Monterey cypress cultivar on southern boundary

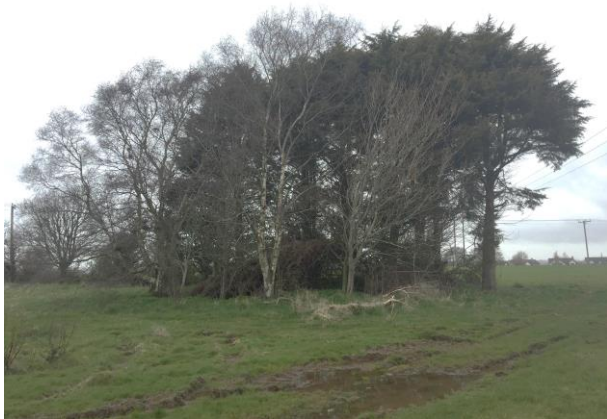
Image 5. Birch and Swedish whitebeam on southern boundary

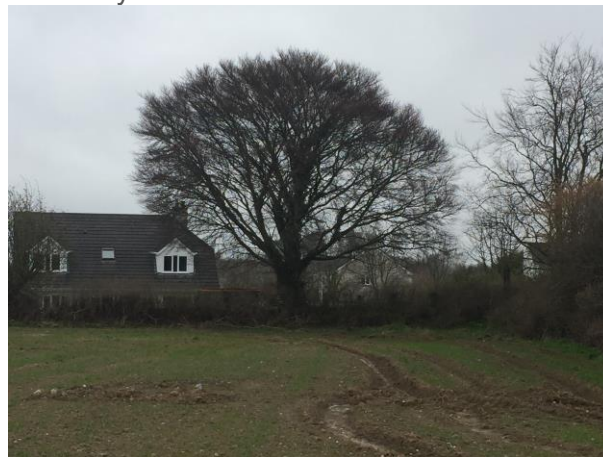
On the northern boundary, there are three large mature beech (*Fagus sylvatica*). Two straddle the boundaries with neighbouring properties (image 6) with one on the boundary with the adjacent green space associated with the Broadfield housing estate. The trees on the boundary with the neighbouring properties are large

Image 6. Mature beech on the northern boundary

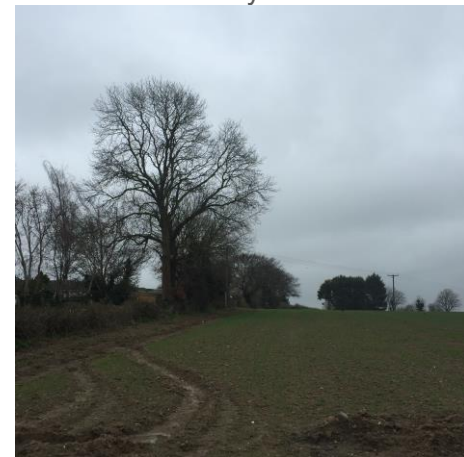
mature specimens with wide spreading crowns extending into the site (image 7).

Image 7. Mature ash within neighbouring properties on the eastern boundary
